**ER0023**  
**Errata**  
**SmartFusion Devices**

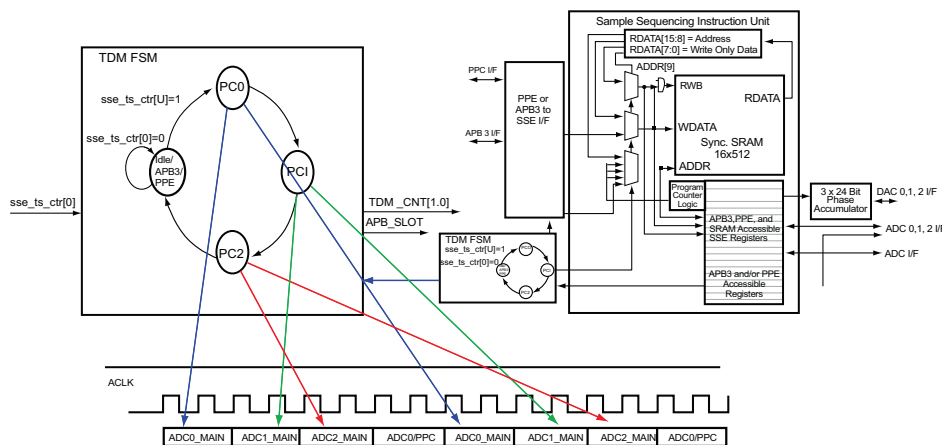
**Figure 1 • SSE Micro Architecture**

The TM4 and CM4 are pads that connect directly to the ADC2 (available only on the A2F500 device). Part of the ACE controller is a Time Division Multiplexing (TDM) FSM, which implements a mechanism to sequence through the different ADCs available on the SmartFusion devices. The FSM allows equal access through three separate program counters. program counter0 (PC0) is associated with ADC0. program counter1 (PC1) is associated with ADC1 and program counter2 (PC2) is associated with ADC2, as shown in the following figure.

The strobe channels on ADC2 (current, temperature, differential voltage) are instead made available through the ADC Controller tab in software on the procedures that are targeted for ADC0 or ADC1 (instead of ADC2 where they are supposed to be available). This is a software workaround. Even though the ADC2 analog signal moved under the PC0 and/or PC1 time slot, physically those analog signals are still connected to ADC2 and are sampled on the ADC2. You should be aware that there will be a contention when sampling is performed on one ADC and then simultaneous samples are performed on the other procedure using the same ADC. The likely outcome of such a scenario is that the samples are dropped. Furthermore, the ACE controller issues a warning, as shown in the following figure.

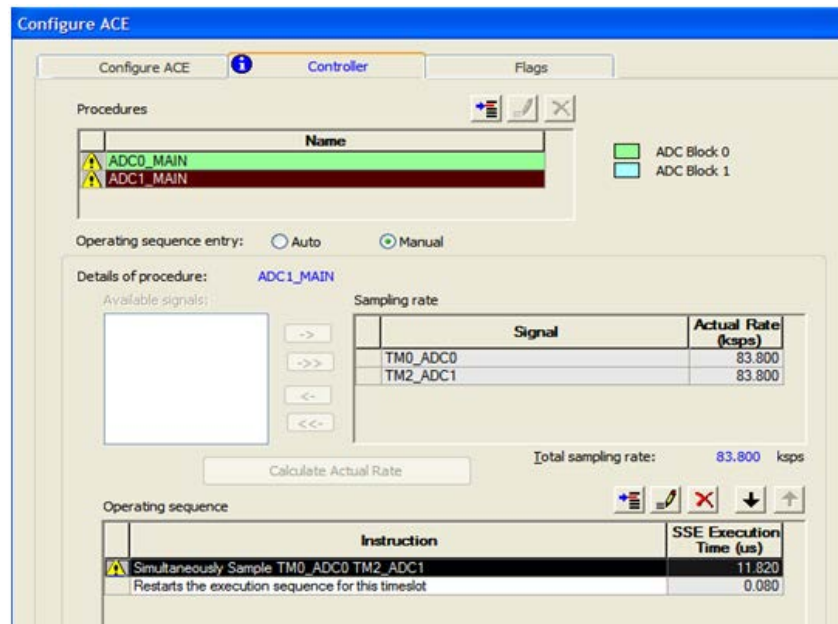
**Figure 2 • Sampling Simultaneous Operations**

**Note:** Sampling of TM0\_ADC0 conflicts with simultaneous operation of procedure(s) for ADC0. See, the ACE Configuration user guide for more information.

*The ACE driver Use Guide* has an API that you can use to enable/disable the procedures.

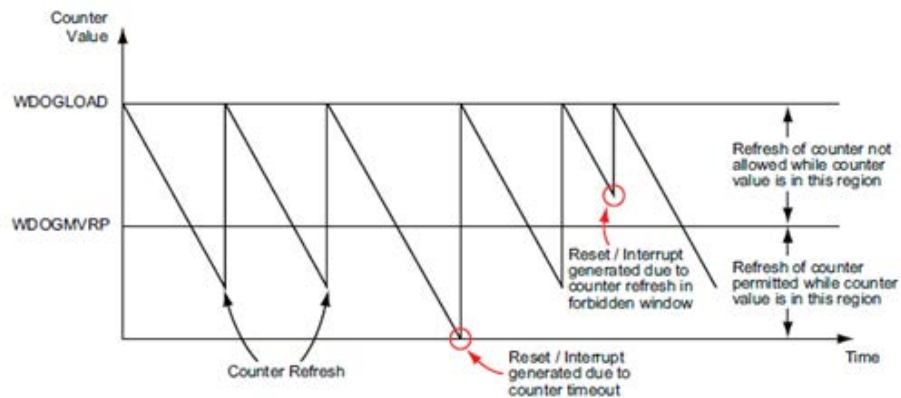
**Figure 3 • Watchdog Timer Windowing Example**

When the counter value falls below the level programmed in WDOGMRP, the Watchdogrefresh is permitted. The REFRESHSTATUS status bit in the WDOGSTATUS register is set when in the permitted window.

Update to Libero software v9.0 SP1 or later release along with MSS version 2.2.101.

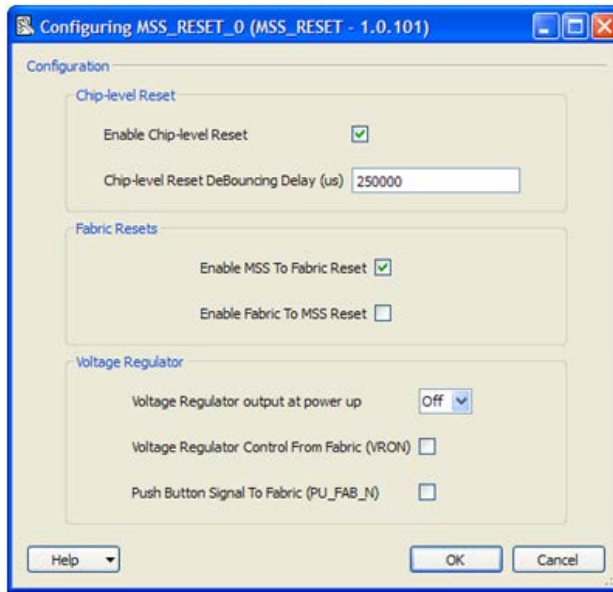
Figure 4 • Reset Management Configurator

This issue happens if the debouncing delay generated by the external reset chip does not match the chip level reset debouncing delay specified in the Reset Management configurator in the MSS, as shown in the following figure.

Ensure that the chip level reset debouncing delay specified in the Reset Management configurator in the MSS matches the external reset chip delay.

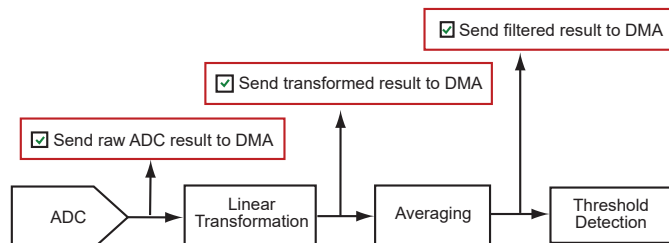
**Figure 7 • ACE Data Path Available Tapping Points**

In Libero SoC v10 SP1, the PPE microcode is incorrectly generated when **Send filtered value to DMA** is enabled. Prior to Libero SoC v10 SP1 the microcode was generated correctly.

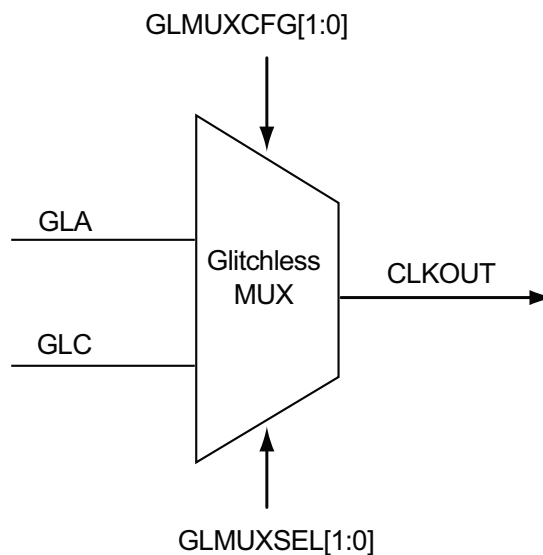
Figure 8 • Glitchless Multiplexer

The NGMUX is a 2:1 multiplexer that switches glitch-free between two different clock sources and outputs the new clock to the global network, as shown in the following figure. Before switching the NGMUX, the clock source being switched to must be stable to avoid clock glitches propagation through the NGMUX. If not, the NGMUX can propagate those glitches.

The signal assigned to the GCAx pins (Example: GCA0/IO36NDB1V0, GCA1/IO36PDB1V0, and others) as a CLKBUF or CLKBUF\_LVPECL or CLKBUF\_LVDS goes through the glitchless mux. For the glitchless mux to operate correctly, the signal must be a free-running clock signal. See the “**Glitchless MUX**” section in the *SmartFusion Microcontroller Subsystem User Guide* for more information. Verify that the signal driving this instance is a continuous clock signal.
