PIC32MM0256GPM064 Family Silicon Errata and Data Sheet Clarification

The PIC32MM0256GPM064 family devices that you have received conform functionally to the current Device Data Sheet (DS60001387D), except for the anomalies described in this document.

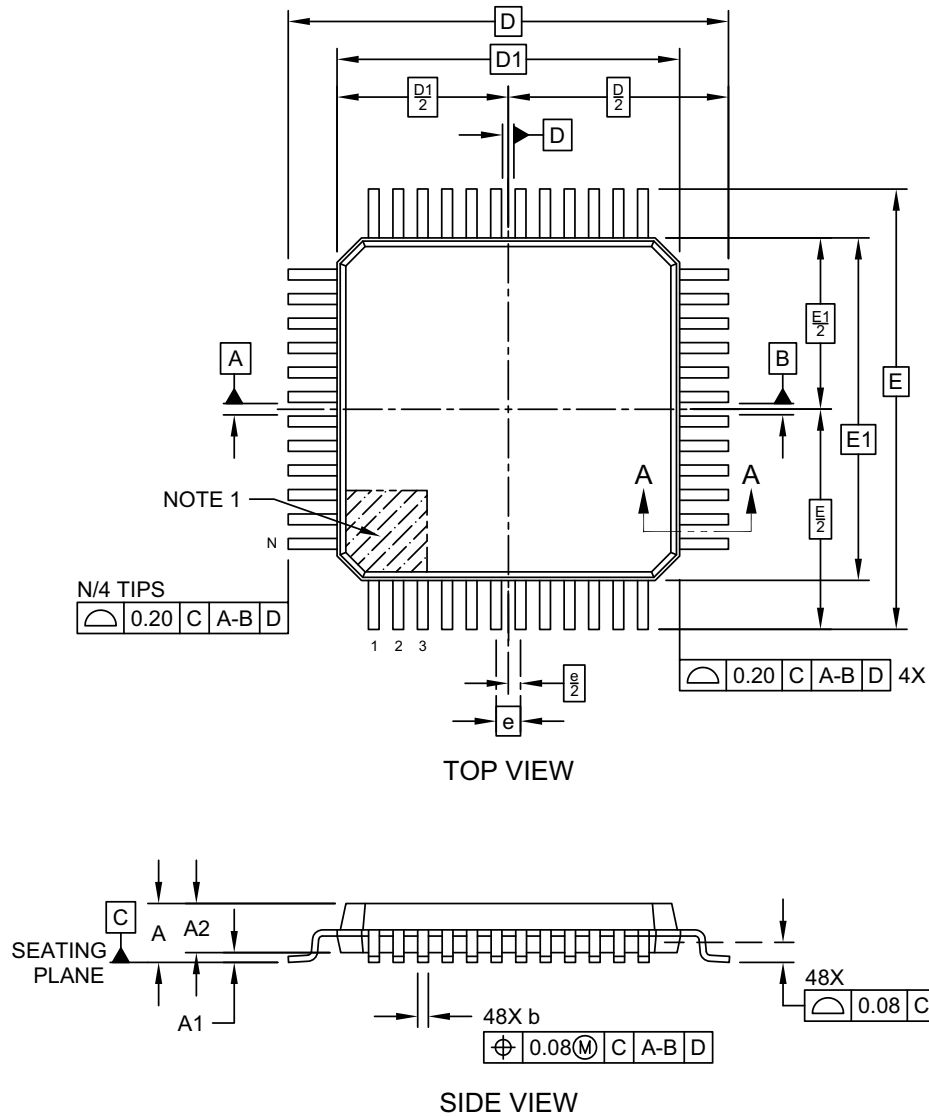
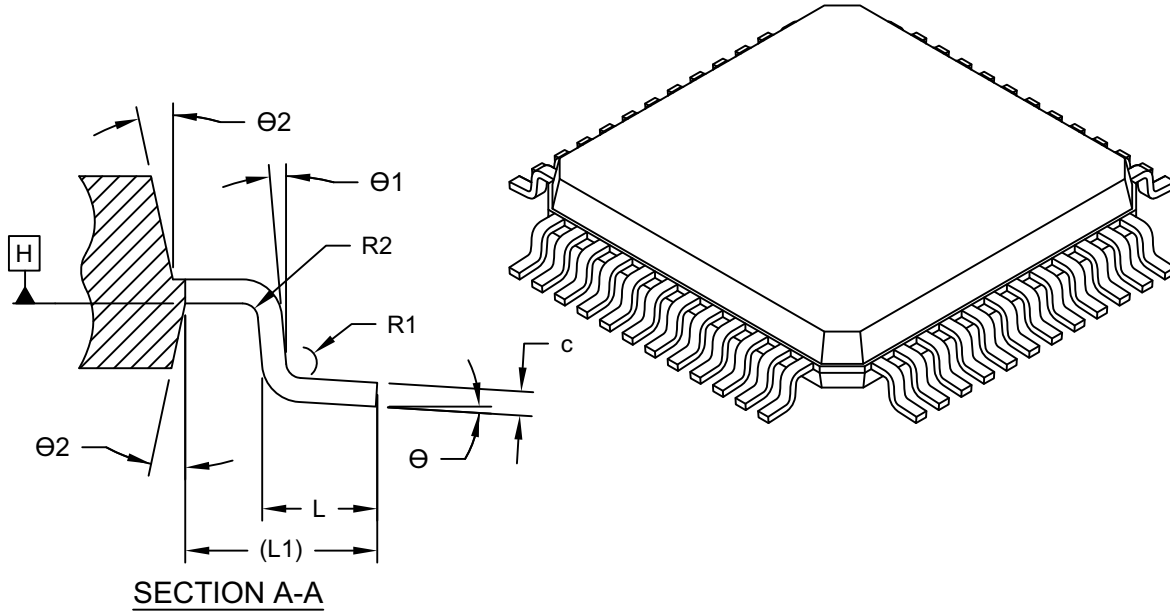
48-Lead Plastic Thin Quad Flatpack (Y8X) - 7x7x1.0 mm Body [TQFP]

3. Module: Package Details/Drawing: 48-Pin TQFP

The following figure shows the updated package drawing for the 48-Pin TQFP Device:

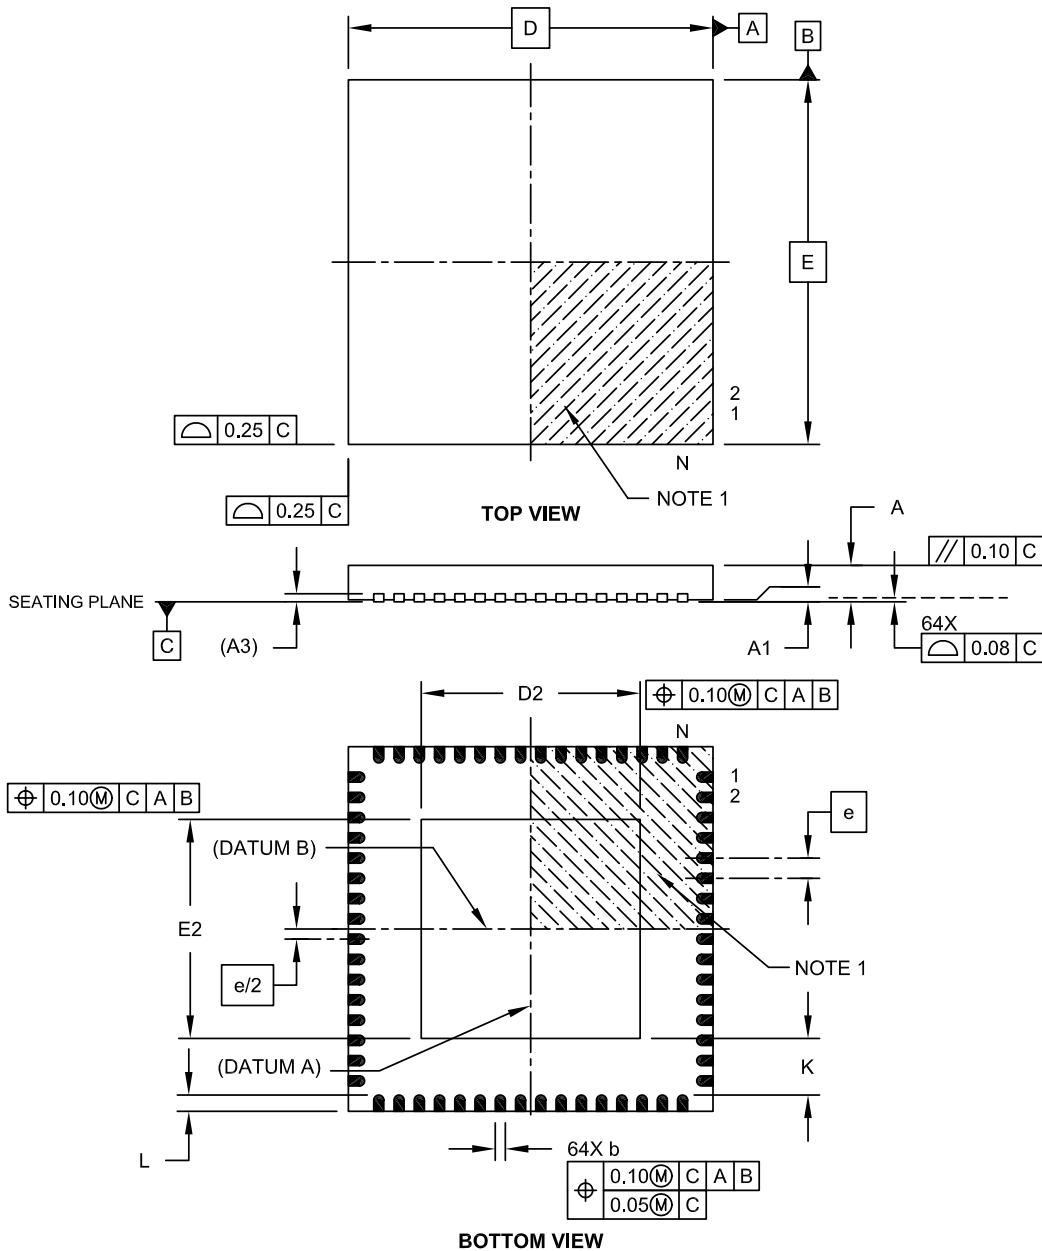
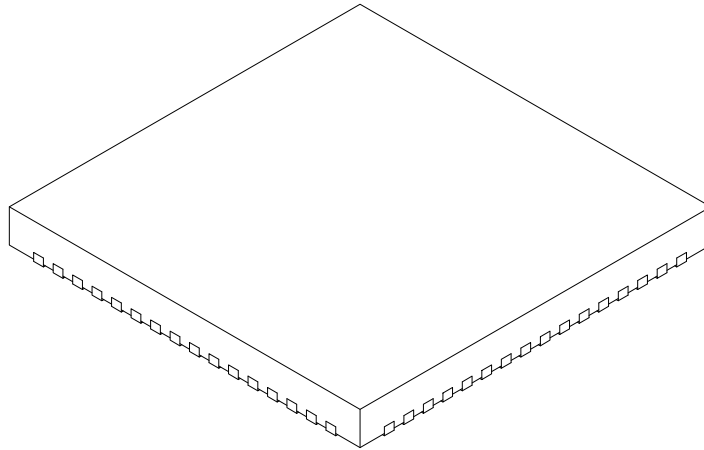
64-Lead Plastic Quad Flat, No Lead Package (MR) – 9x9x0.9 mm Body with 5.40 x 5.40 Exposed Pad [QFN]

5. Module: Package Details/Drawing: 64-Pin QFN

The following figure shows the updated package drawing for the 64-Pin QFN device.
