# PIC32MZ EF FAMILY

## PIC32MZ Embedded Connectivity with Floating Point Unit (EF) Family Silicon Errata and Data Sheet Clarification

The PIC32MZ Embedded Connectivity with Floating Point Unit (EF) family of devices that you have received conform functionally to the current Device Data Sheet (DS60001320G), except for the anomalies described in this document.

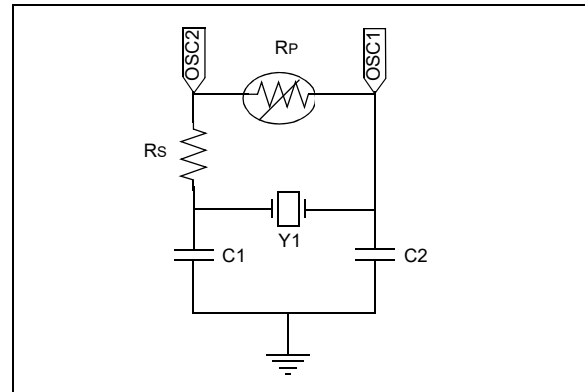
**FIGURE 1: Posc CRYSTAL CIRCUIT**

**Revision A1 Silicon:** A crystal oscillator cannot be used as an input to the Primary Oscillator (Posc) pins OSC1 and OSC2.

**Revision A3 and B2 Silicon:** The Posc has been tested in a normal power-up sequence and supports specific crystal operation.

The Primary Oscillator (Posc) has been characterized to operate at 8 MHz, 12 MHz, and 24 MHz when the circuit in [Figure 1](#) is implemented, and the operating conditions listed in [Table 3](#) are met.

- Note 1:** Using any other crystal frequency will require special component selection and characterization.  
**Note 2:** A parallel resistor (Rp) should not be used to increase the gain of the POSC.

#### Silicon Work around 1

#### Silicon Work around 2

Alternatively, use an external clock or the Internal FRC oscillator.
