# PIC32MZ Graphics (DA) Family

## PIC32MZ Graphics (DA) Family Silicon Errata and Data Sheet Clarification

The PIC32MZ Graphics (DA) family of devices that you have received conform functionally to the current Device Data Sheet (DS60001361H), except for the anomalies described in this document.

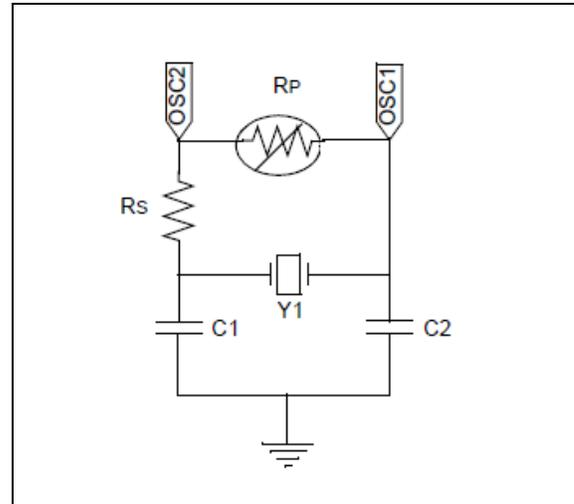
FIGURE 1: Posc CRYSTAL CIRCUIT

The POSC has been tested in a normal power-up sequence and supports specific crystal operation.

The Primary Oscillator (POsc) has been characterized to operate at 8 MHz and 12 MHz when the circuit shown in Figure 1 is implemented, and the operating conditions listed in Table 3 are met.

Crystal Frequency (See Note 1)	Series Resistor Rs	Posc Gain Setting POSCGAIN<1:0> (DEVCFG0<20:19>)	Posc Boost Setting POSCBOOST (DEVCFG0<21>)
8 MHz	2 kΩ	'0b00 (GAIN_0)	'0b1
12 MHz	1 kΩ	'0b00 (GAIN_0)	'0b1

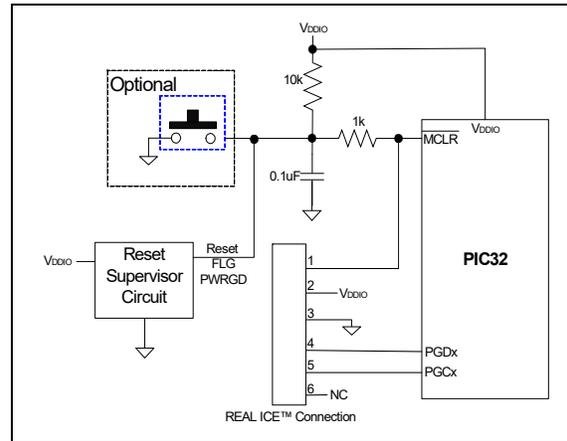
FIGURE 2: EXTERNAL RESET CIRCUIT

A system Reset is not generated on a BOR event ( $V_{PORIO} < V_{DDIO} < V_{BORIO}$ ). This will stop system clocks with all the I/O pin functions frozen in the present state until either  $V_{DDIO}$  falls to  $V_{PORIO}$  or  $V_{DDIO} > V_{BORIO}$ .

Reset device using a  $\overline{MCLR}$  pin through an external reset supervisor/monitor is shown in Figure 2. Set the SMCLR (DEVCFG2<15>) configuration bit to '0', which makes the  $\overline{MCLR}$  to act as a POR Reset instead of a normal system reset.

- Minimum Reset trip voltage of the external supervisor should be  $V_{BORIO} (\text{Max}) + 0.5V$ .
- The external reset supervisor/LDO output going to  $\overline{MCLR}$  should have an open drain output to not interfere with the MPLAB programming/debug tools.

When this work around is implemented, the minimum  $V_{DDIO}$  operating voltage of the application needs to be above the reset supervisor maximum trip voltage + 0.2V, where 0.2V compensates for variation in the external reset supervisor voltage.
