# Microchip Studio

## Microchip Studio Release Note

Microchip Studio for AVR® and SAM Devices is an integrated development platform from Microchip. It provides a modern and powerful environment for doing AVR® and Arm® development.

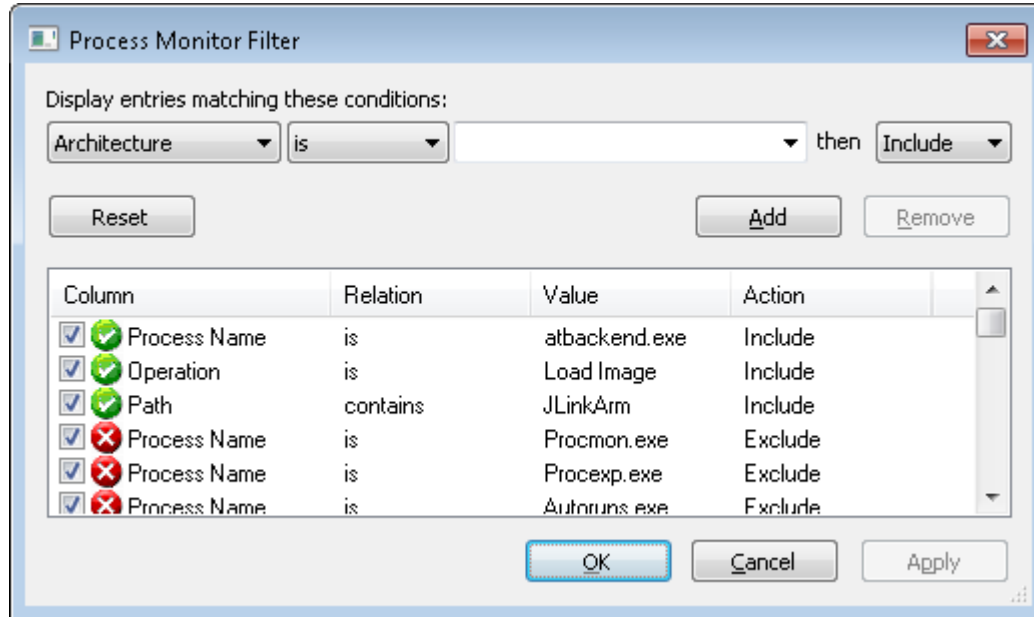
Download the Procmon tool, open it, and configure the filter, as shown in the figure below, and start Microchip Studio. A couple of seconds after Microchip Studio has started, one line may become visible, showing the path to where the dll is being loaded from. It may be loaded from the `atbackend` folder inside the Microchip Studio installation directory.

**Figure 2-2. Procmon Filter Configuration**
